## TEST REPORT

External Mechanical Impacts (IK 10)

230400122TPE-001

Zoom Bullet with D/N / A422

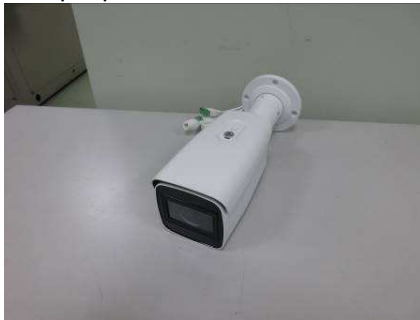
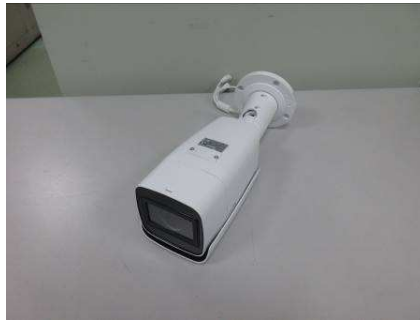
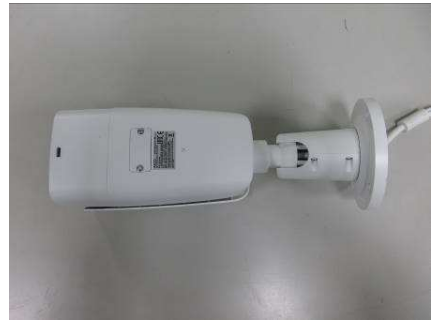
-Sample photo before the test:

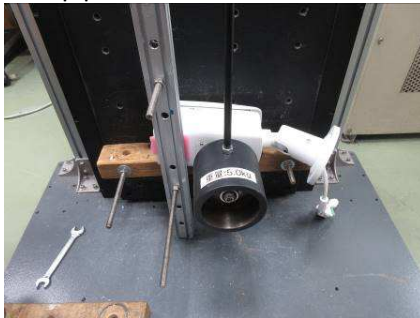
-Setup photo:

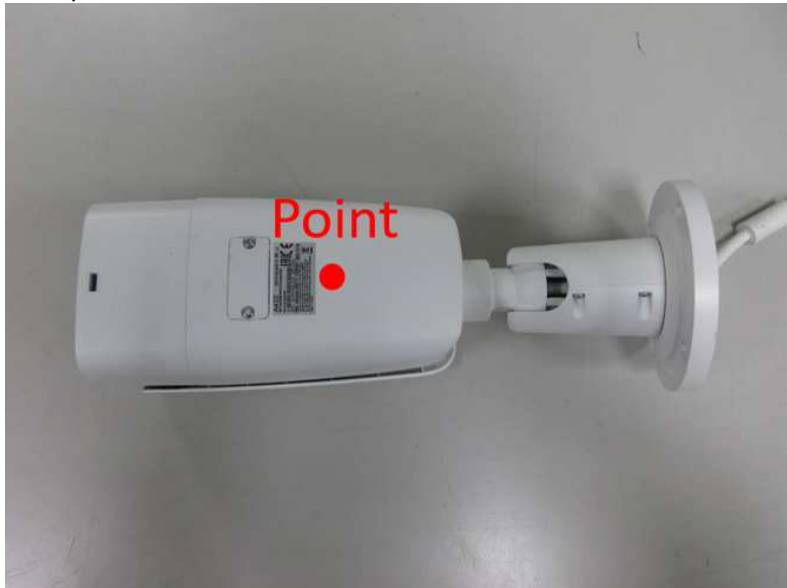
- Non operation test
- Test energy: 20.0 joules
- Equivalent mass: 5.0 kg
- Fall height: 400 mm
- Number of impacts: 1 times/point

-Test point:

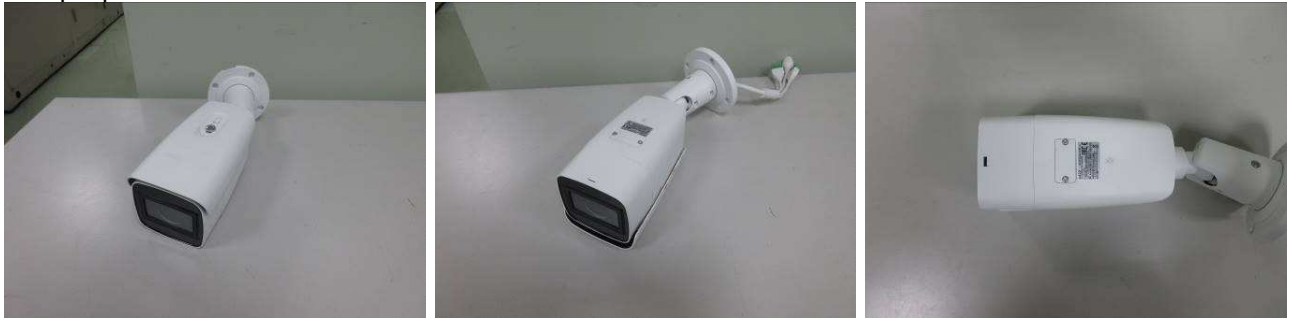
- No visible damage was found on sample appearance after the test.
- Sample photo after the test:
