TEST REPORT

CTK-2025-00793

NETWORK THERMAL CAMERA / TNM-C2722TDR

KS C IEC 62262: 2005

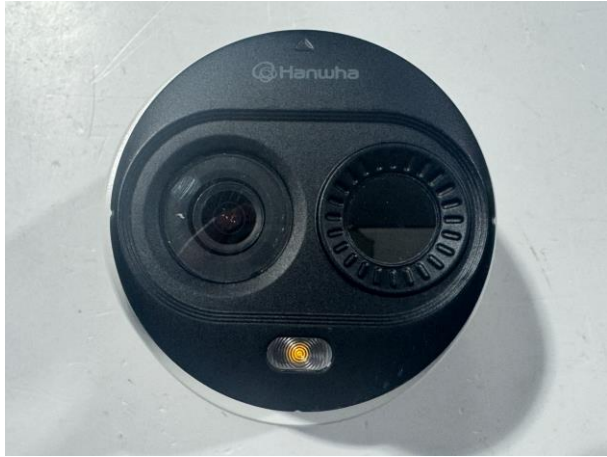
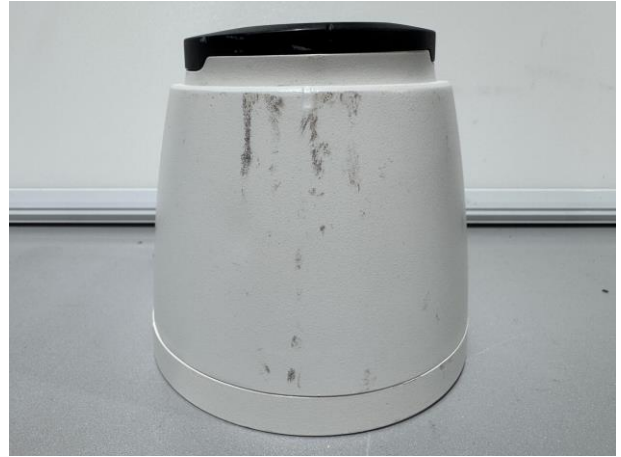
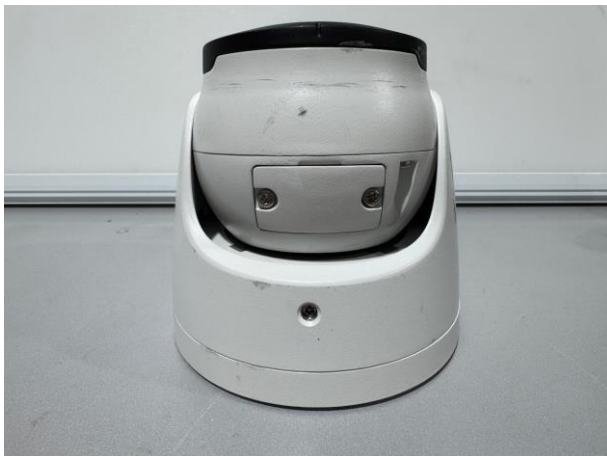
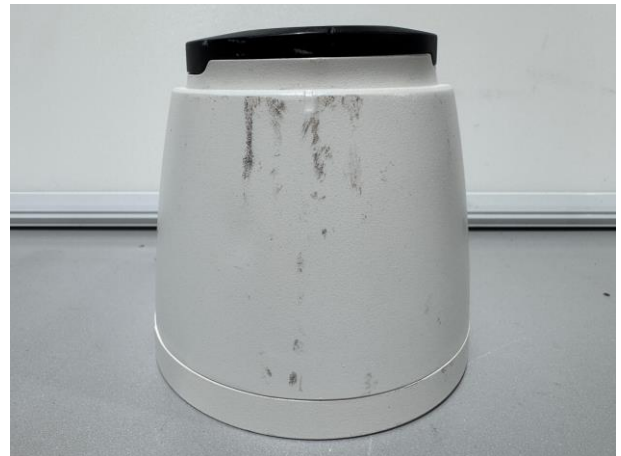
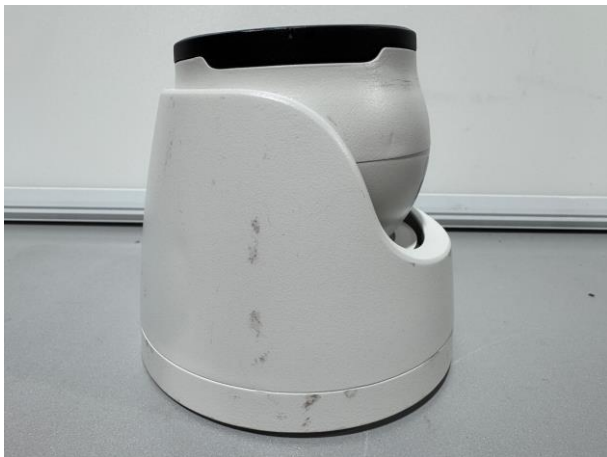
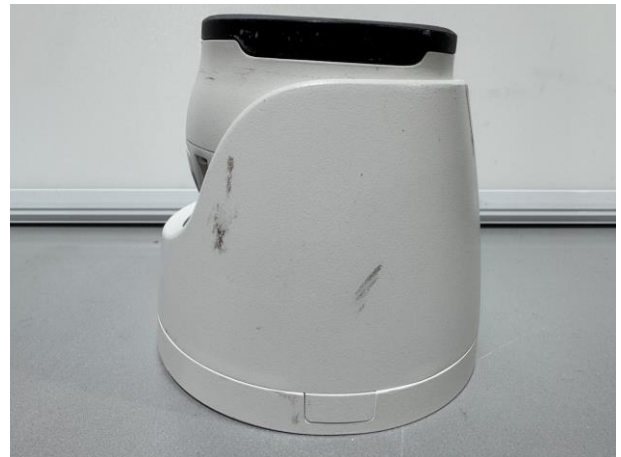
4.3.1 Post-test product image

Evaluation Criteria		시험 결과	비고
Visual Inspection	Pre-test	No problem with the product	Except for the front lens part of the impact area
	Post-test	Some scratches were generated on the outside of the product.
