TEST REPORT

Continuous Immersion Test - IPX8

Dust Test - IP6X

Outdoor Turret with D/N / Z53

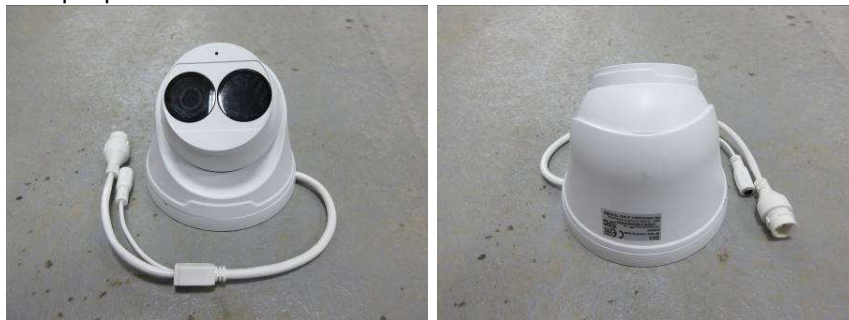
-Sample photo before the test:

-Sample size: 1 unit

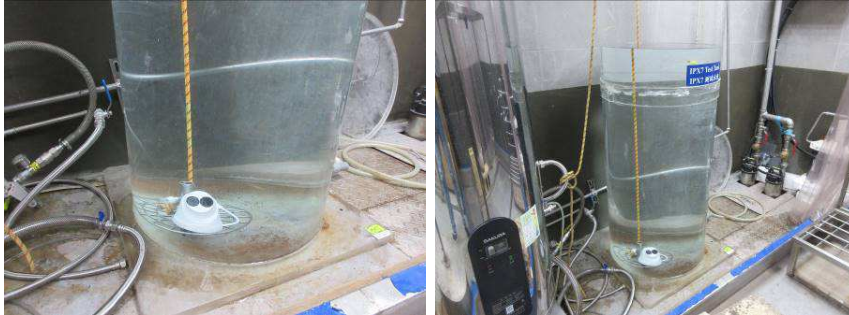
-Setup photo:

Immersion depth : 1100 mm (between the surface of the water and sample's bottom)

The duration of the test : 30 minutes

- Check the sample's appearance before test.
- Immerse the sample into water per test condition.
- After the immersion, take out sample from water.
- Observe the sample and record for any visible change after testing.

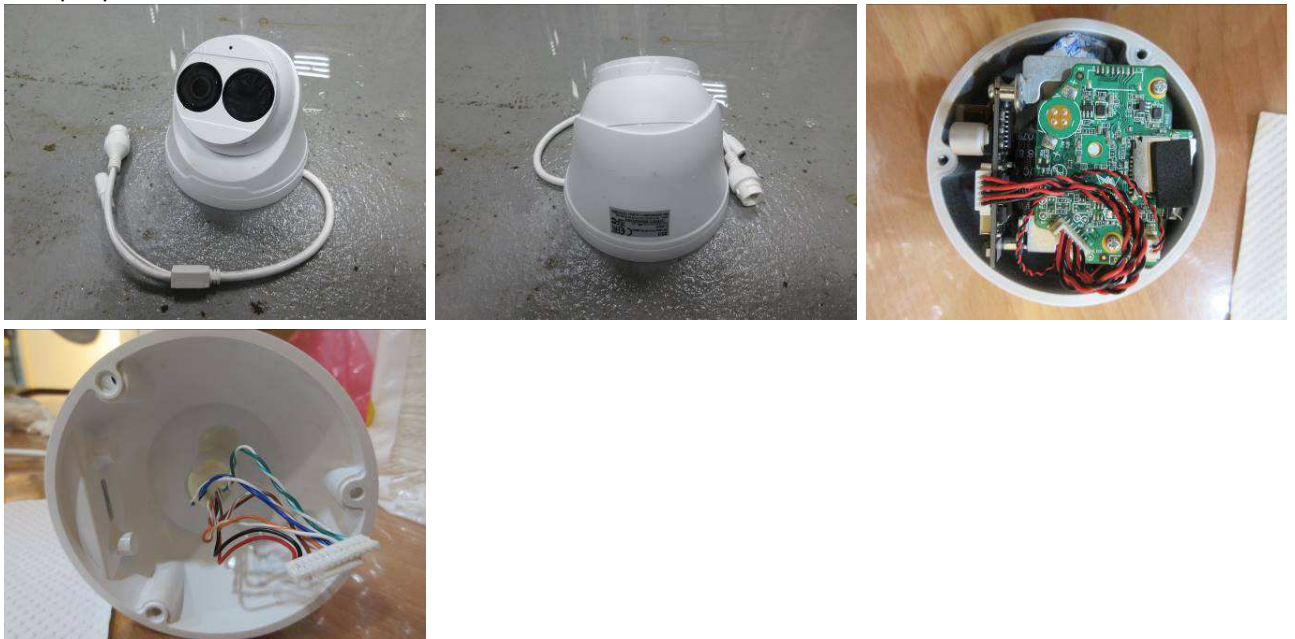
-Sample photo after the test:

- No visible damage was found.
- Checking of sample appearance and inside after the test was conducted by the applicant per applicant's request.

No water penetrated into the tested sample.

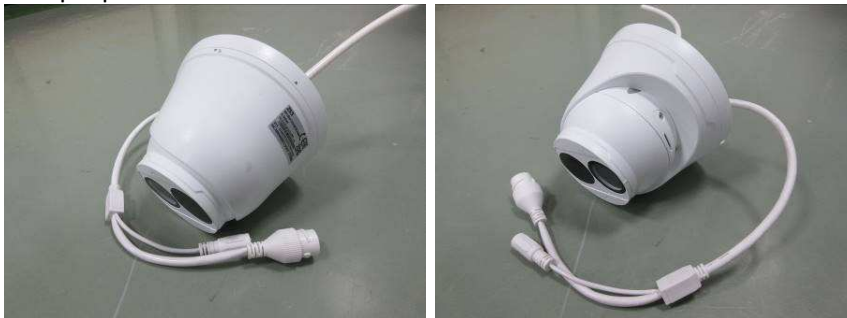
-Sample photo before the test:

-Sample size: 1 unit

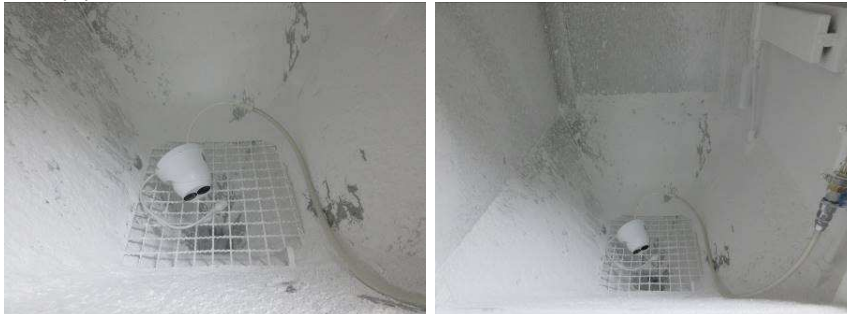
-Setup photo:

-Talcum powder size: < 0.075 mm

-The amount of talcum powder: 2 kg per cubic meter

-Under pressure: 20 mbar

-Test duration: 8 hours

-Install the sample to the chamber and setup testing condition.

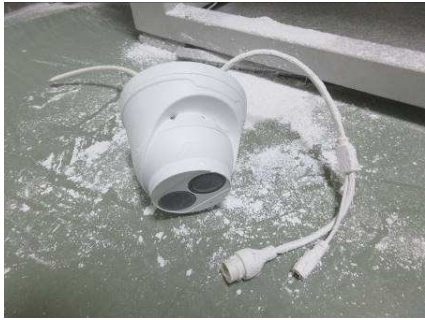
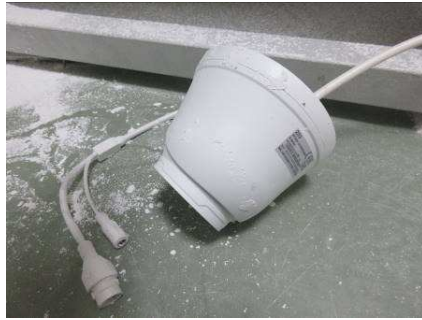
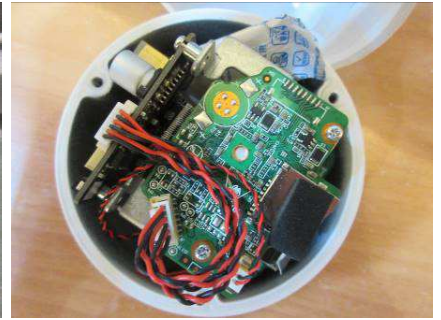
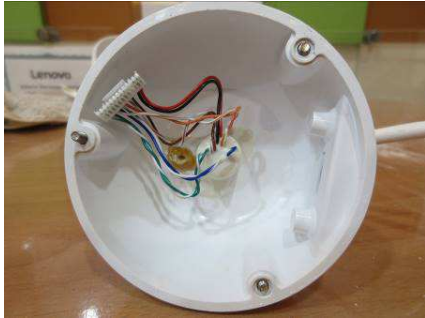
- No visible damage was found on sample appearance after the test.
- Checking for the inside of tested sample after testing is conducted by the applicant per applicant's request.
- No dust penetrated into tested sample.
- Sample photo after the test:
