# TEST REPORT

REPORT No.:  
CTK-2025-01329  
Page (1) / (14) pages

Cabinet / SBP-050NBW

IEC 60529:1989 +A1:1999+A2:2013

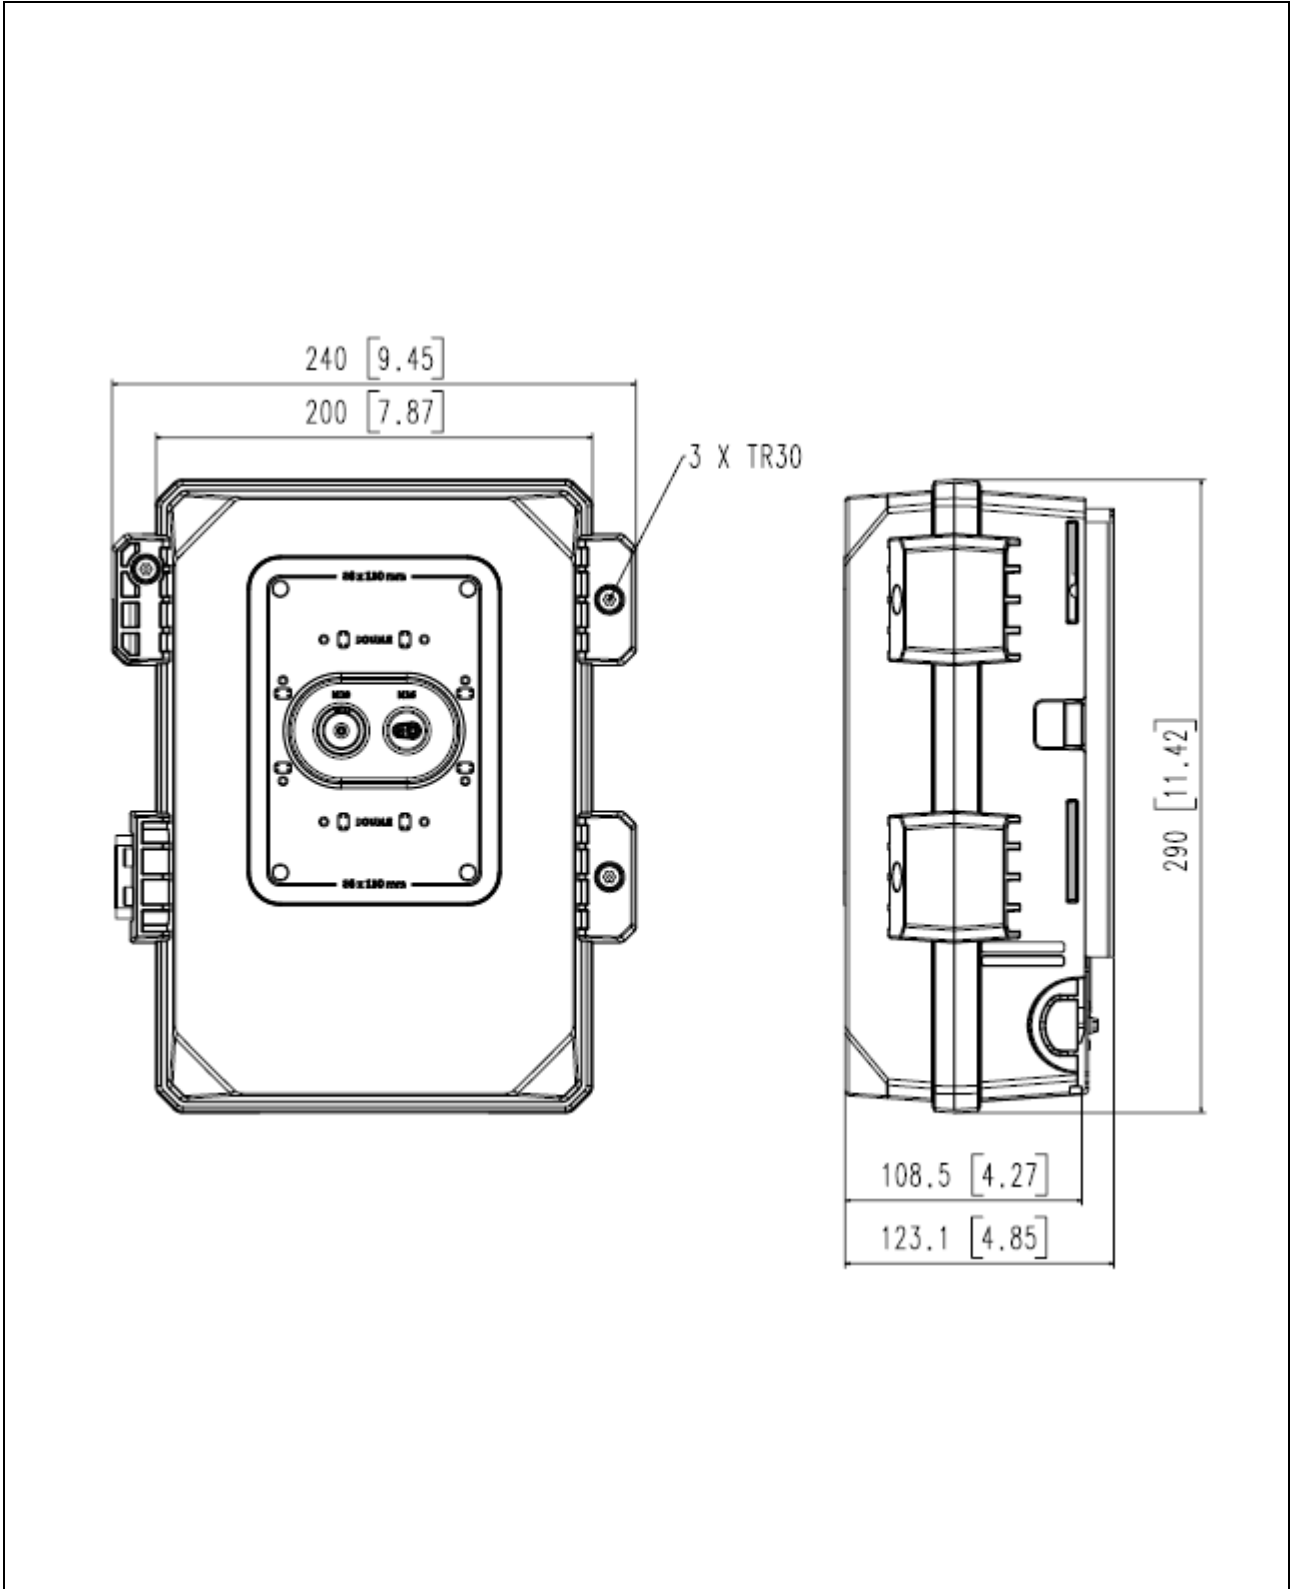
Enclosure dimensions [unit : mm]

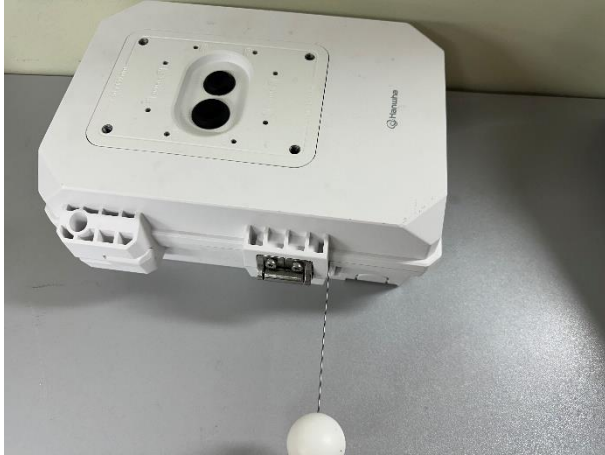
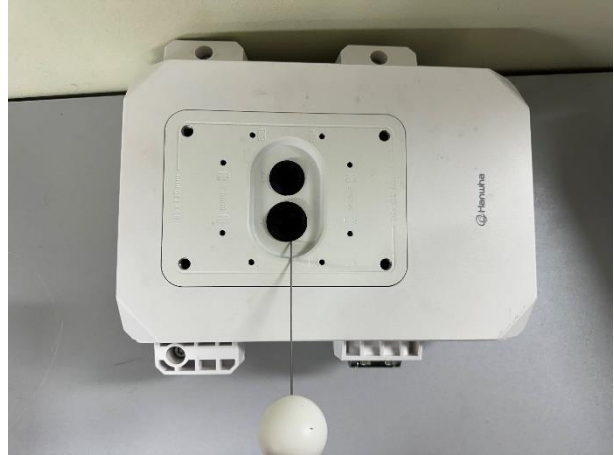
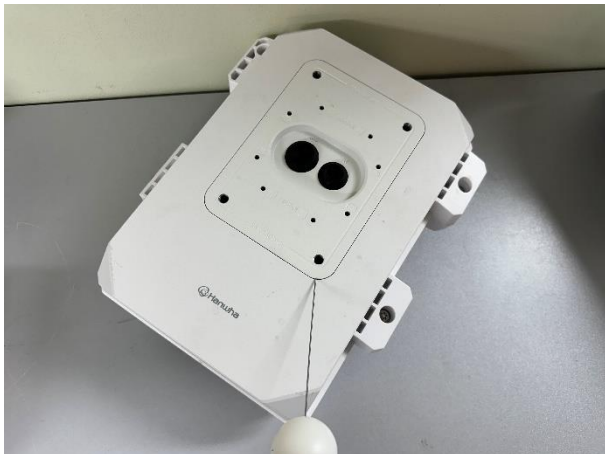
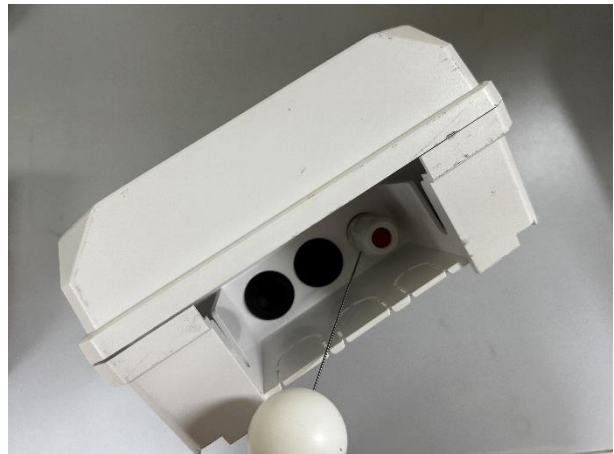
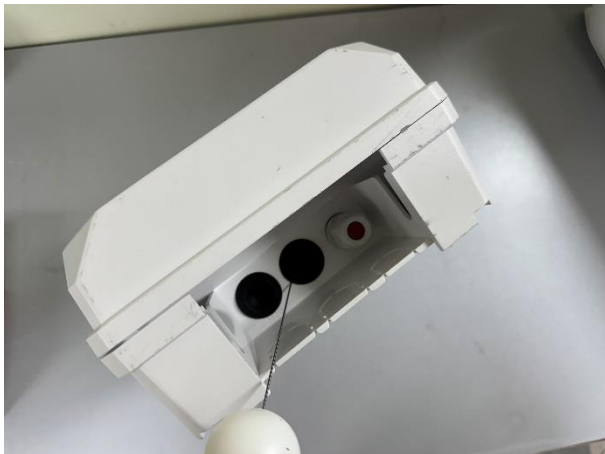
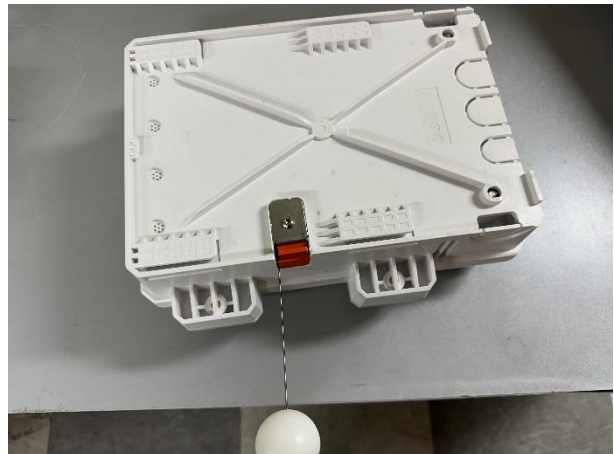
Probe test

First characteristic numeral	Degree of protection	Application
6	Protected against access to hazardous parts with a wire. The access probe of 1.0 mmØ, shall not penetrate. Test force: 1 N ± 10 %	<input checked="" type="checkbox"/>

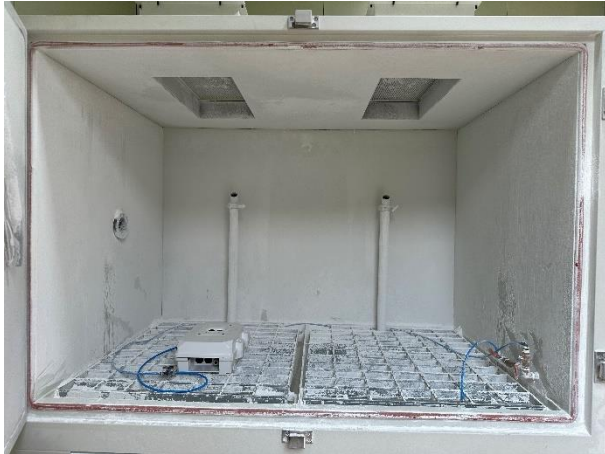
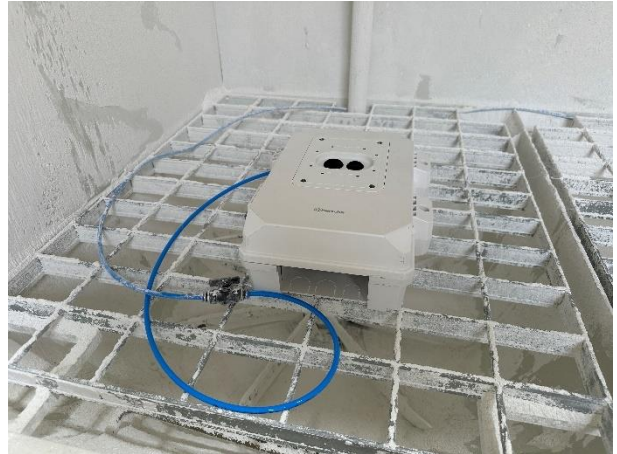
Dust test

First characteristic numeral	Degree of protection	Application
6	<p>In Dust Testing Equipment, the test sample must have no ingress of dust after testing atmospheric pressure present condition for 8 h.</p> <p>(The talcum powder must pass through a calibrated sieve with a 50 µm wire mesh, spaced at 75 µm intervals in a square pattern. Additionally, the bulk density of the talcum powder should be 2 kg/m<sup>3</sup>)</p> <p>Products in volume .....: <b>7 139.8 cm<sup>3</sup> → 7.14 L</b></p> <p>Target intake volume (Products in volume 80) : <b>571.18 L</b></p> <p>Suction volume (Max product in volume 60) ...: <b>428.39 LPH → 7.14 LPM</b></p> <p>Actual Suction volume .....: <b>7.14 L</b></p> <p>Suction pressure (Up to 2 kPa) .....: <b>1.62 kPa</b></p> <p>Test time (Up to 8 time) .....: <b>8 hr</b></p>	☒

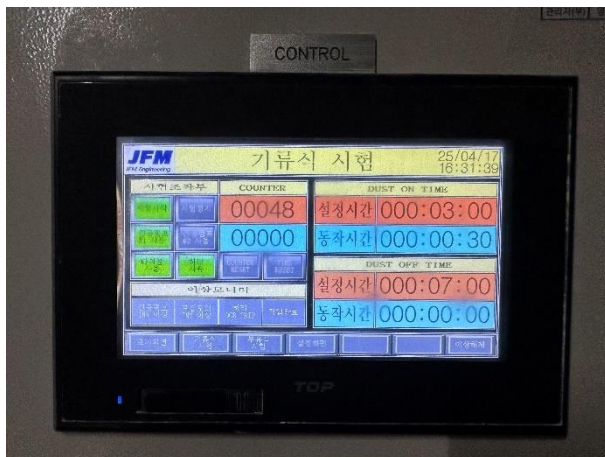
Dust test Monitor

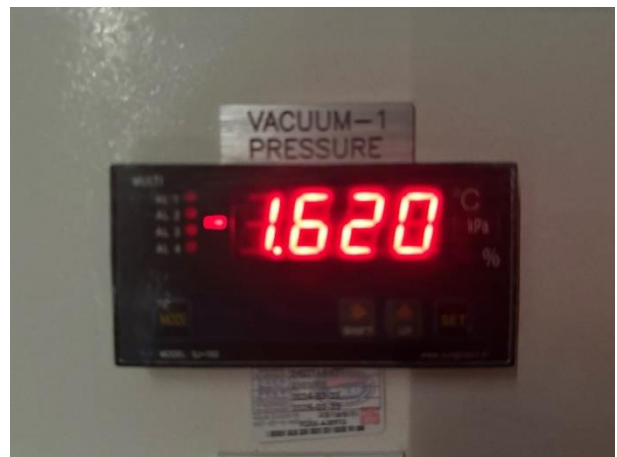
Digital Vacuum Pressure

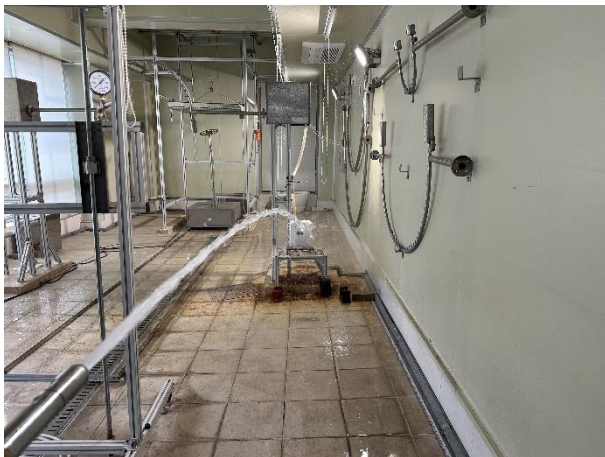
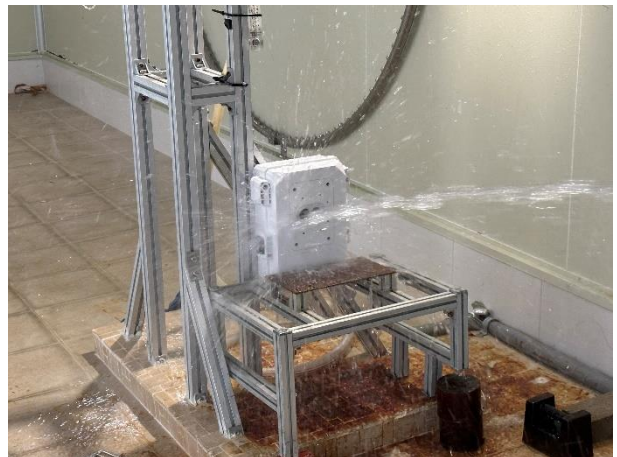
Water test

Second characteristic numeral	Degrees of protection	Application
6	<p>The product must not be harmed in any direction even strong jet water.</p> <p>Water jet hose nozzle Fig.6, Nozzle 12.5 mm diameter</p> <p>Water flow rate: 100 l/min ± 5 % : <b>100 LPM</b></p> <p>Distance: 2.5 m to 3 m: <b>3 m</b></p> <p>Duration of test: 1 min/m<sup>2</sup> at least 3 min: <b>3 min</b></p>	☒

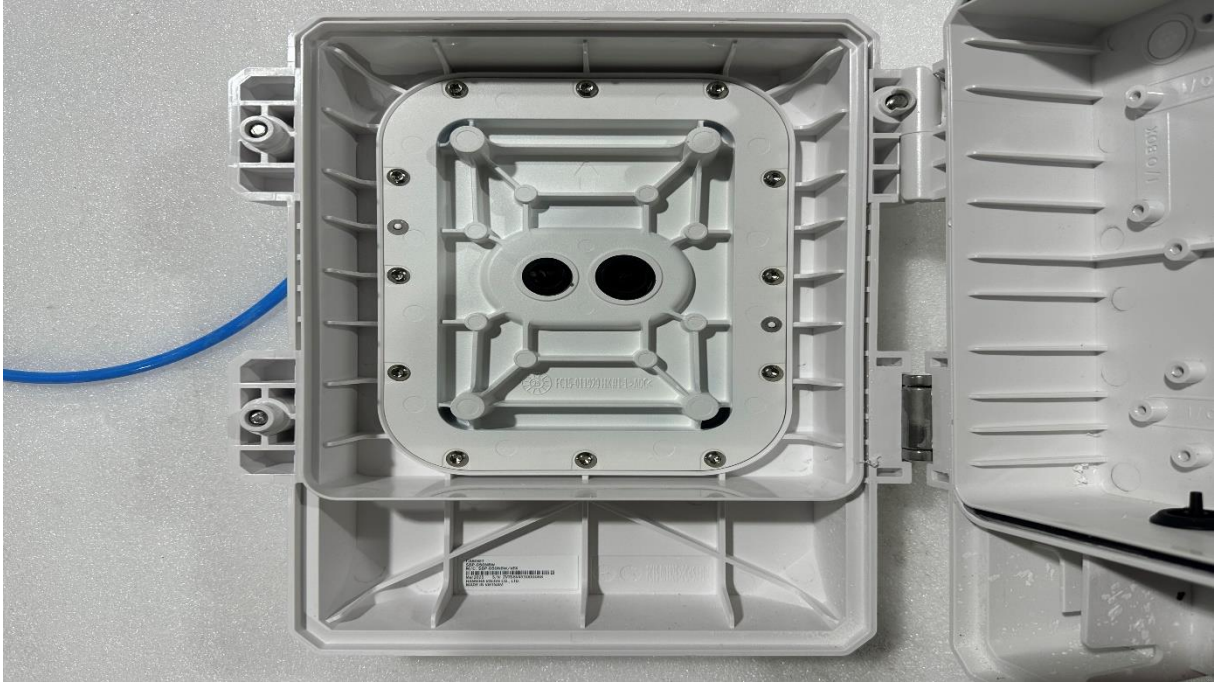
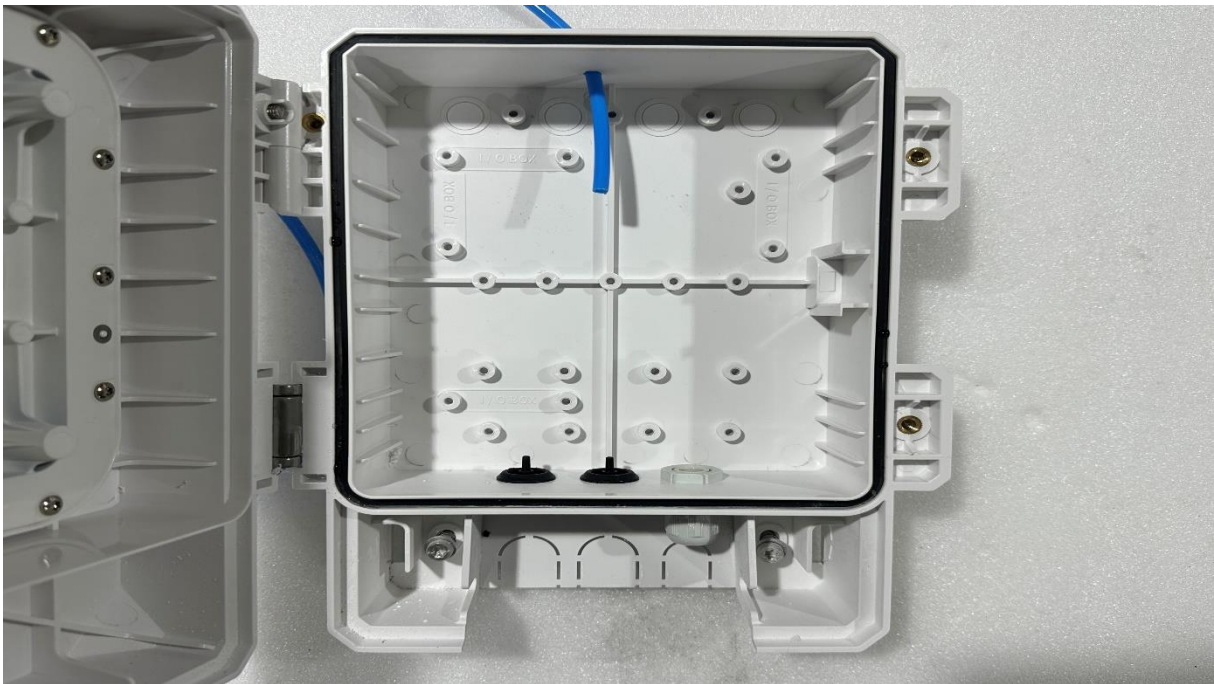
### 3.5.1 Product internal images after test [The first characteristic numeral test]

IP code	Evaluation Criteria	Test Results	Remark
IP 6X	No ingress of Probe	Normal	-
	No ingress of dust	Normal	-
IP X6	No ingress of water	Normal	-

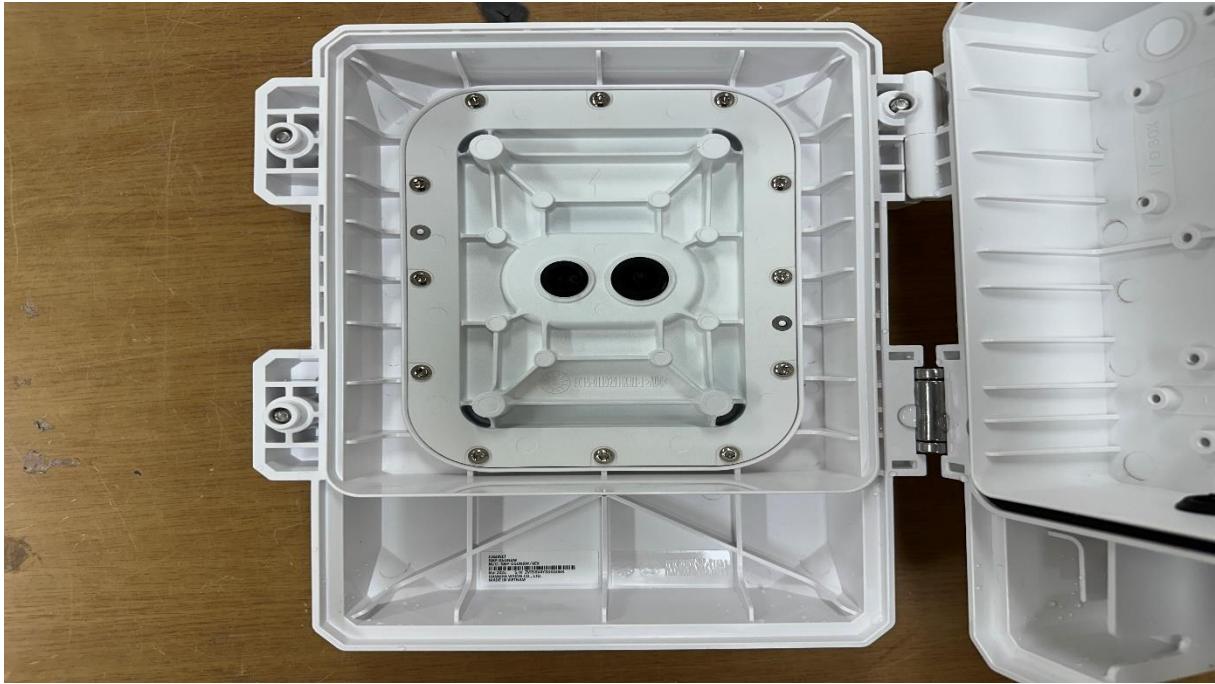
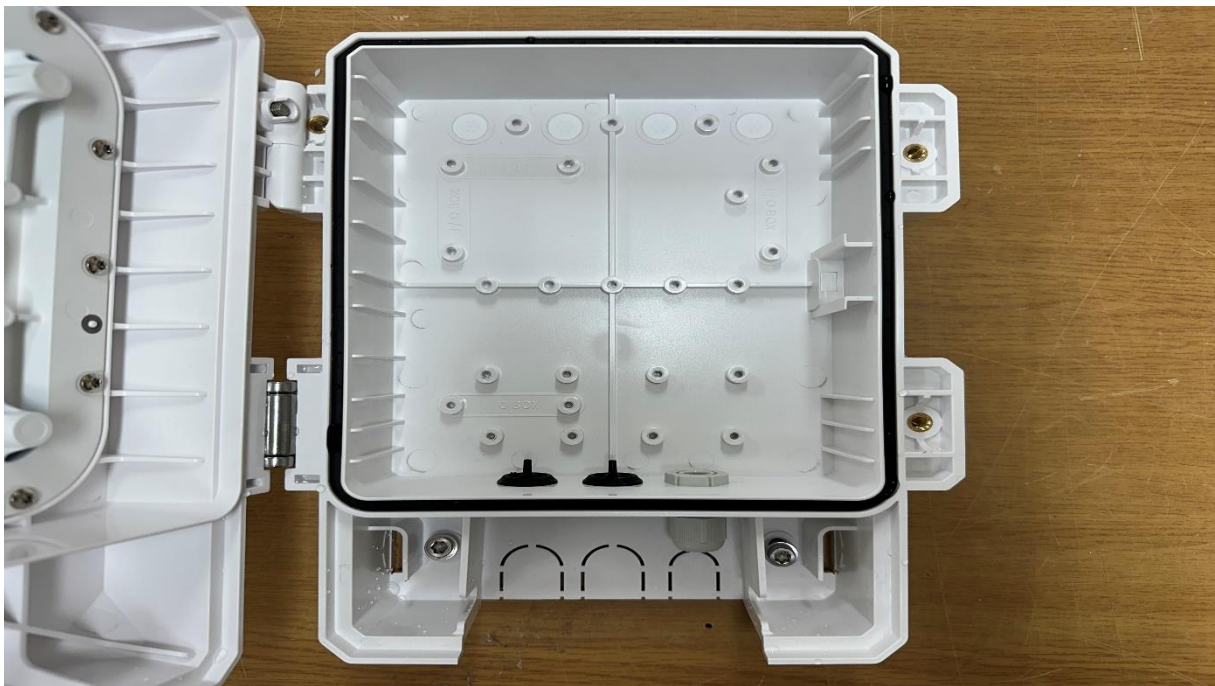
#### 3.5.2 Product internal images after test [The second characteristic numeral test]
