# TEST REPORT

CTK-2025-00791

NETWORK THERMAL CAMERA / TNM-C2722TDR

IEC 60529:1989 +A1:1999+A2:2013

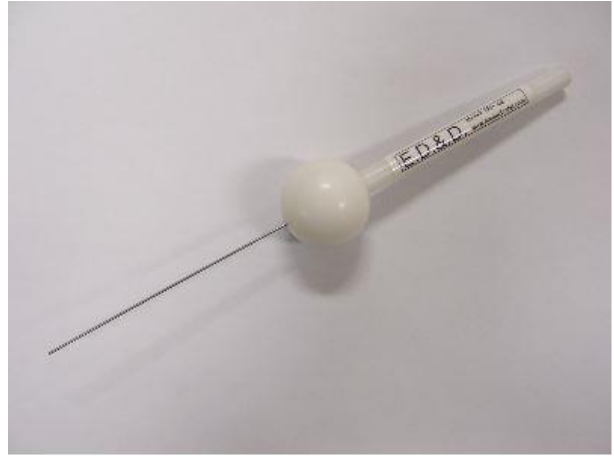
Test Rod Probe Ø1.0

First characteristic numeral	Degree of protection	Application
6	Protected against access to hazardous parts with a wire. The access probe of 1.0 mmØ, shall not penetrate. Test force: 1 N ± 10 %	<input checked="" type="checkbox"/>

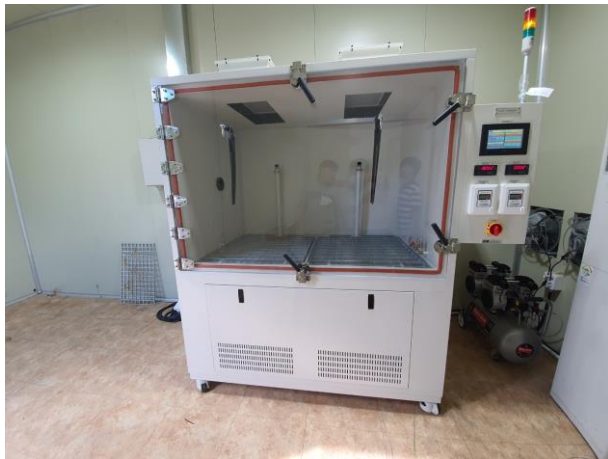
Dust Chamber

First characteristic numeral	Degree of protection	Application
6	<p>In Dust Testing Equipment, the test sample must have no ingress of dust after testing atmospheric pressure present condition for 8 h.</p> <p>(The talcum powder must pass through a calibrated sieve with a 50 µm wire mesh, spaced at 75 µm intervals in a square pattern. Additionally, the bulk density of the talcum powder should be 2 kg/m<sup>3</sup>)</p> <p>Products in volume .....: <b>879.78 cm<sup>3</sup> → 0.88 L</b></p> <p>Target intake volume (Products in volume 80) : <b>70.38 L</b></p> <p>Suction volume (Max product in volume 60) ...: <b>52.79 LPH → 0.88 LPM</b></p> <p>Actual Suction volume .....: <b>0.88 L</b></p> <p>Suction pressure (Up to 2 kPa) .....: <b>1.76 kPa</b></p> <p>Test time (Up to 8 time) .....: <b>8 hr</b></p>	☒

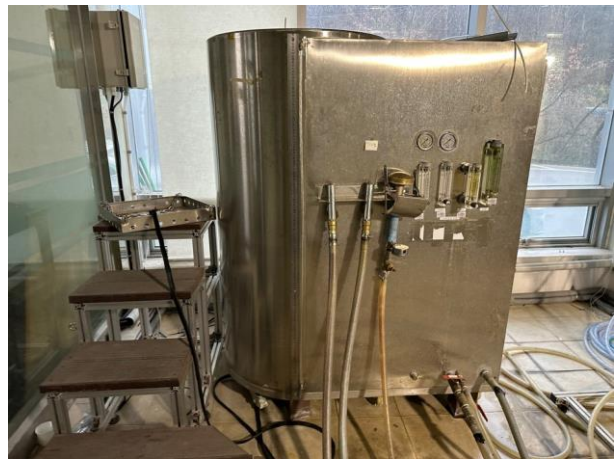
Immersion tank

Second characteristic numeral	Degrees of protection	Application
7	<p>Sink the product in the water by the Pressure and Time according to regulation and the product must not be harmed.</p> <p>Immersion tank water-level on enclosure with:</p> <p><input type="checkbox"/> height equal to or greater than 850 mm: the highest point of enclosures located 0.15 m below the surface of the water</p> <p><input checked="" type="checkbox"/> height less than 850 mm: the lowest point of enclosures located 1 m below the surface of the water</p> <p>Duration of test: 30 min</p>	☒

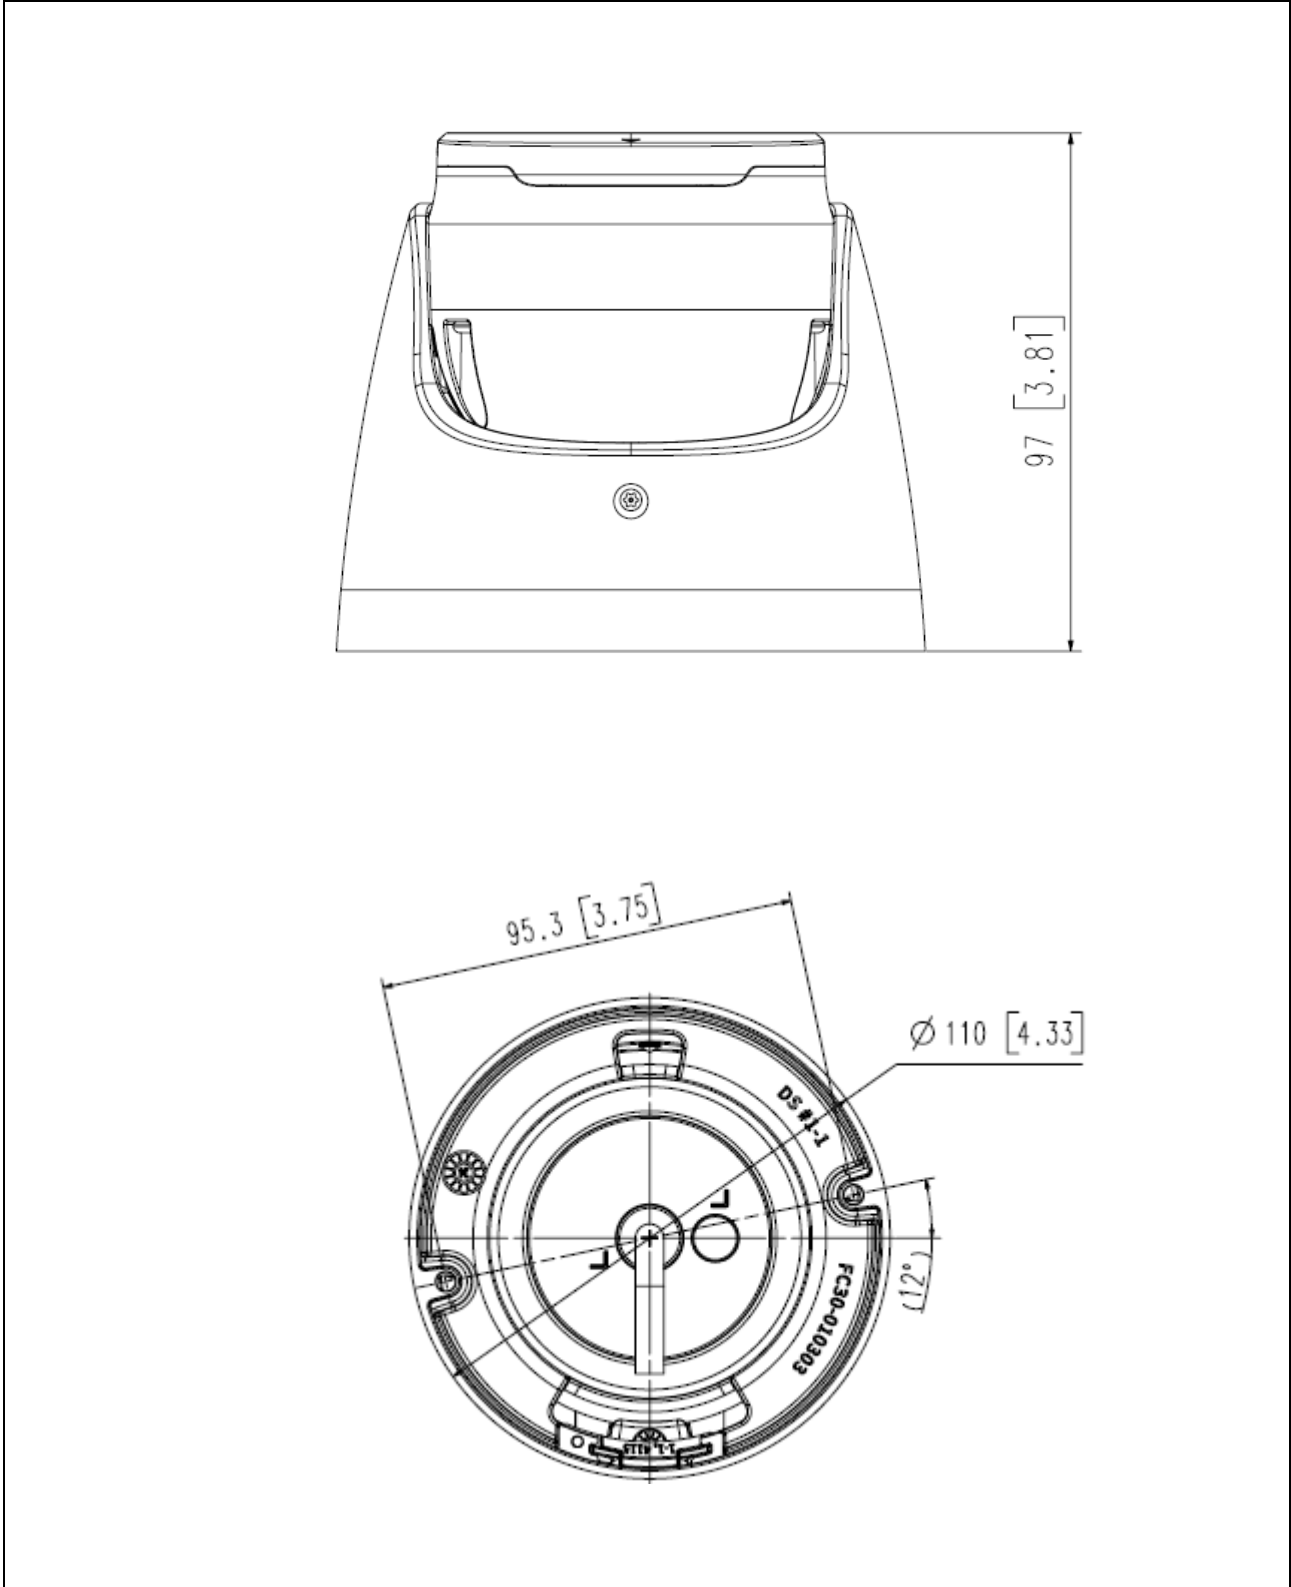
Enclosure dimensions [unit : mm]

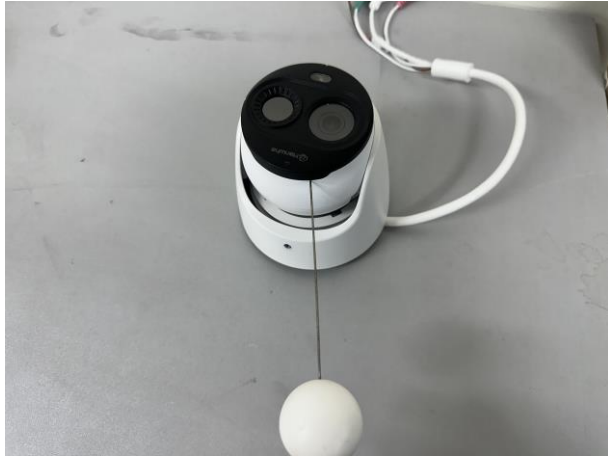
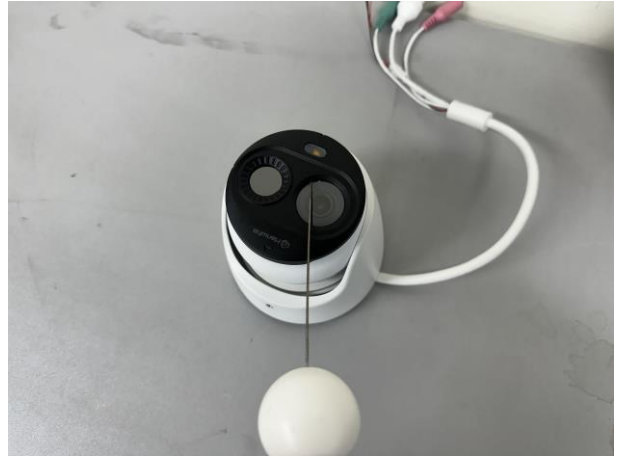
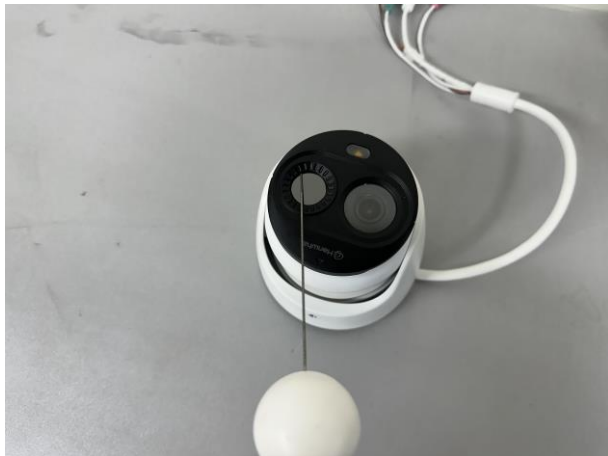
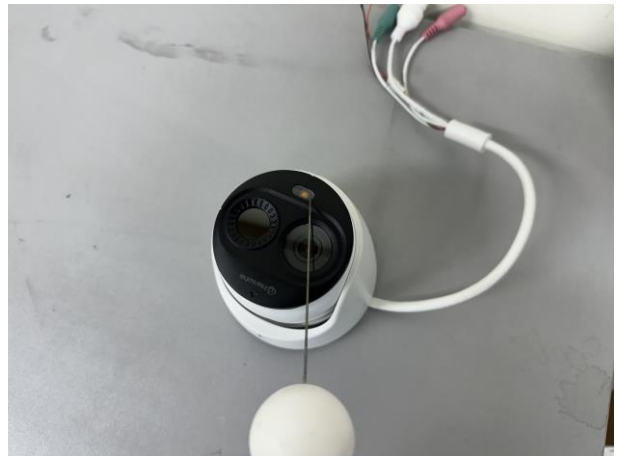
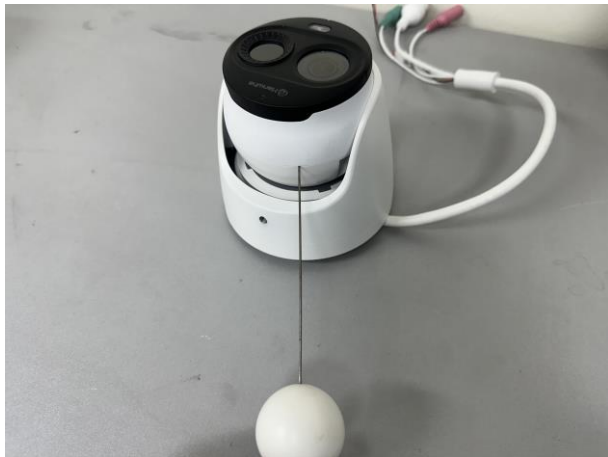
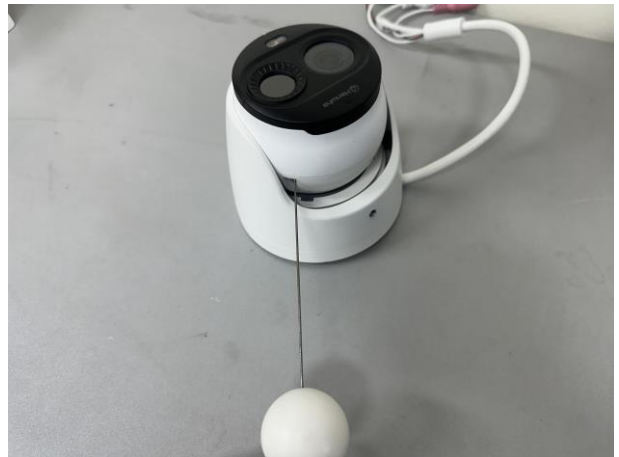
3.3.1 Evidence of test setting (1)

Probe test

IP code	Evaluation Criteria	Test Results	Remark
IP 6X	No ingress of Probe	Normal	-
	No ingress of dust	Normal	-
IP X7	No ingress of water	Normal	-

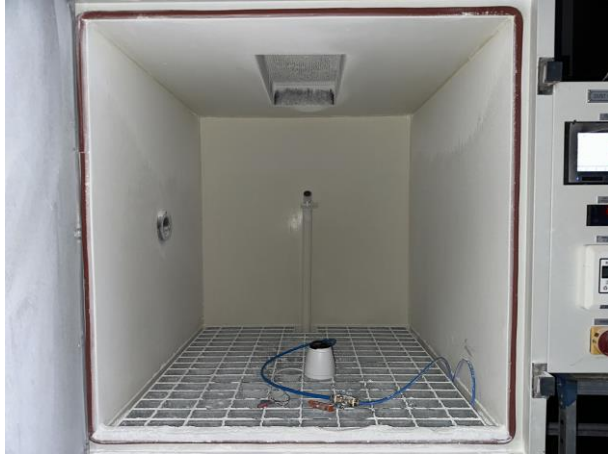
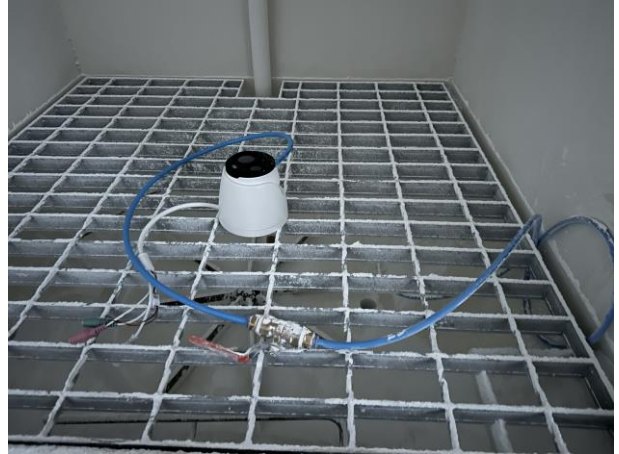
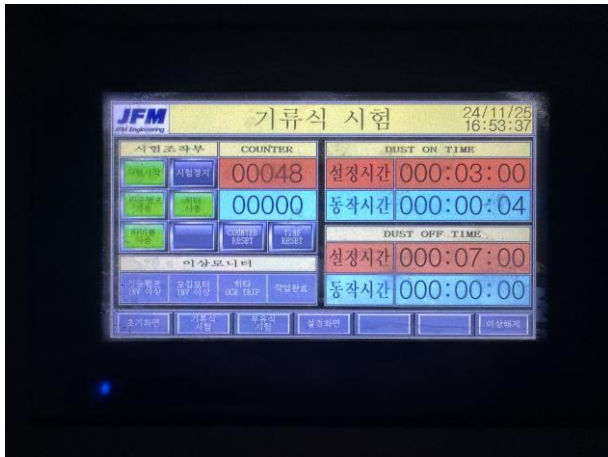
### 3.3.2 Evidence of test setting (2)

Dust test

Dust test Monitor

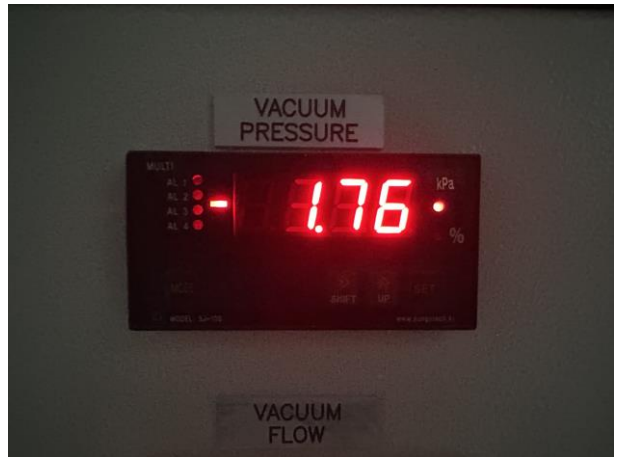
Digital Vacuum Pressure

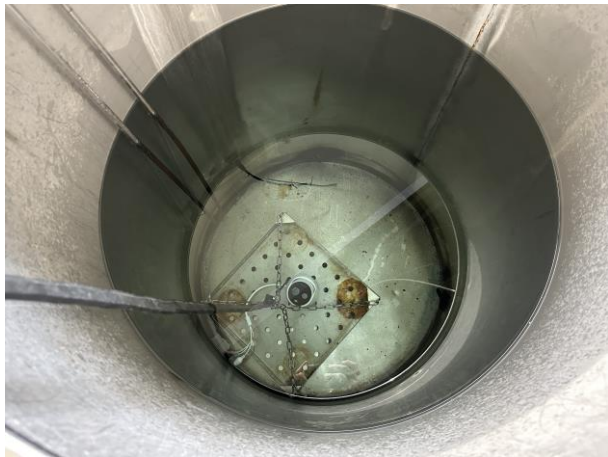
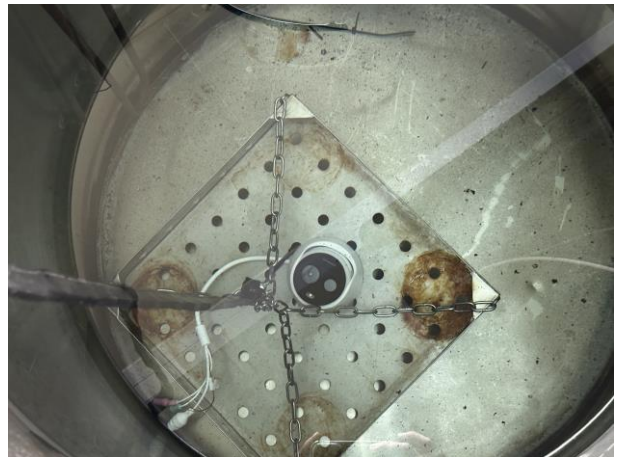
Water test

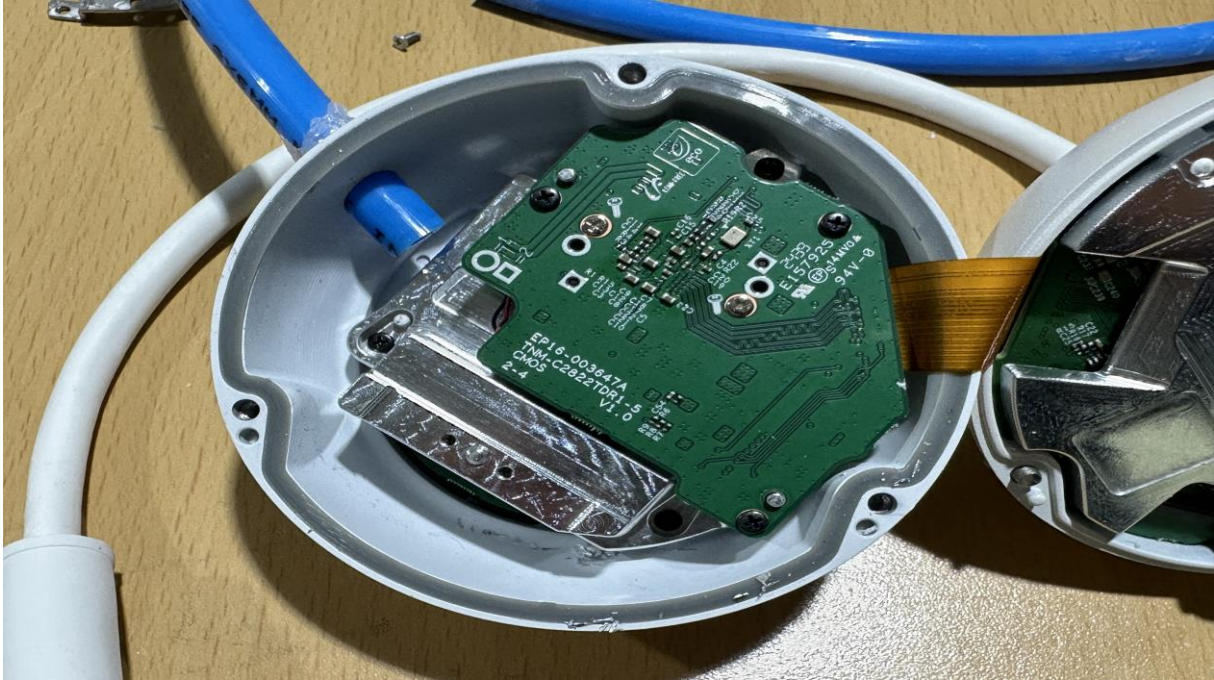
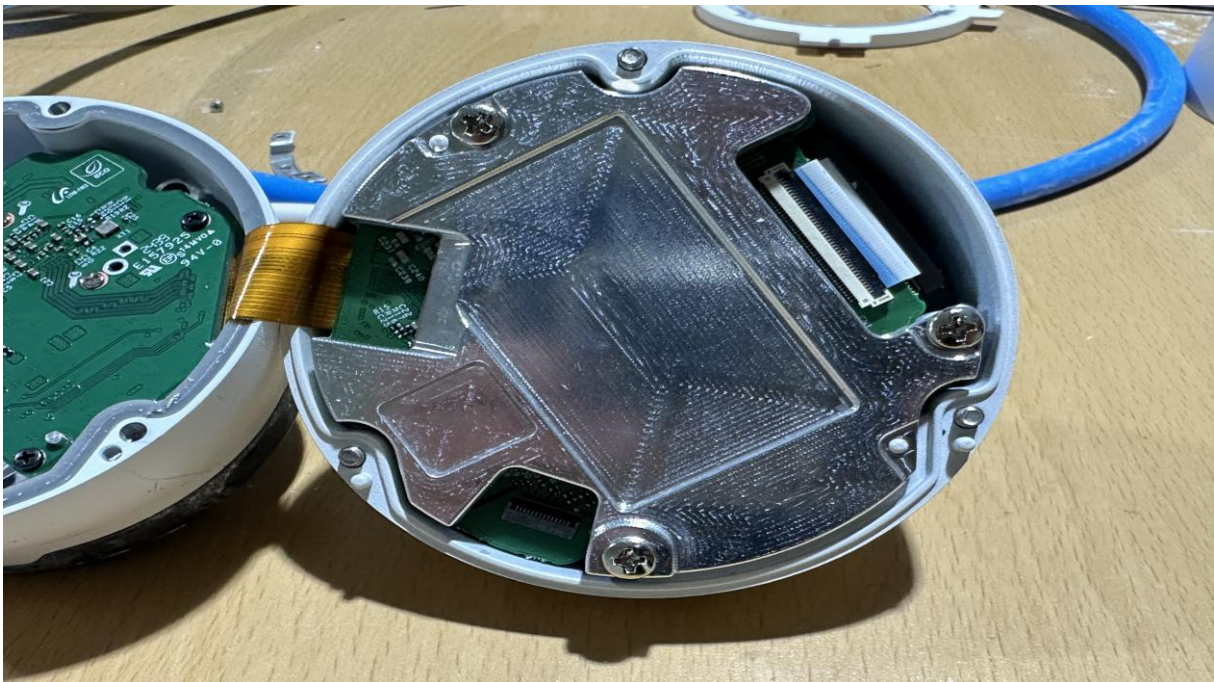
#### 4.2.1 Product internal images after test [The first characteristic numeral test]

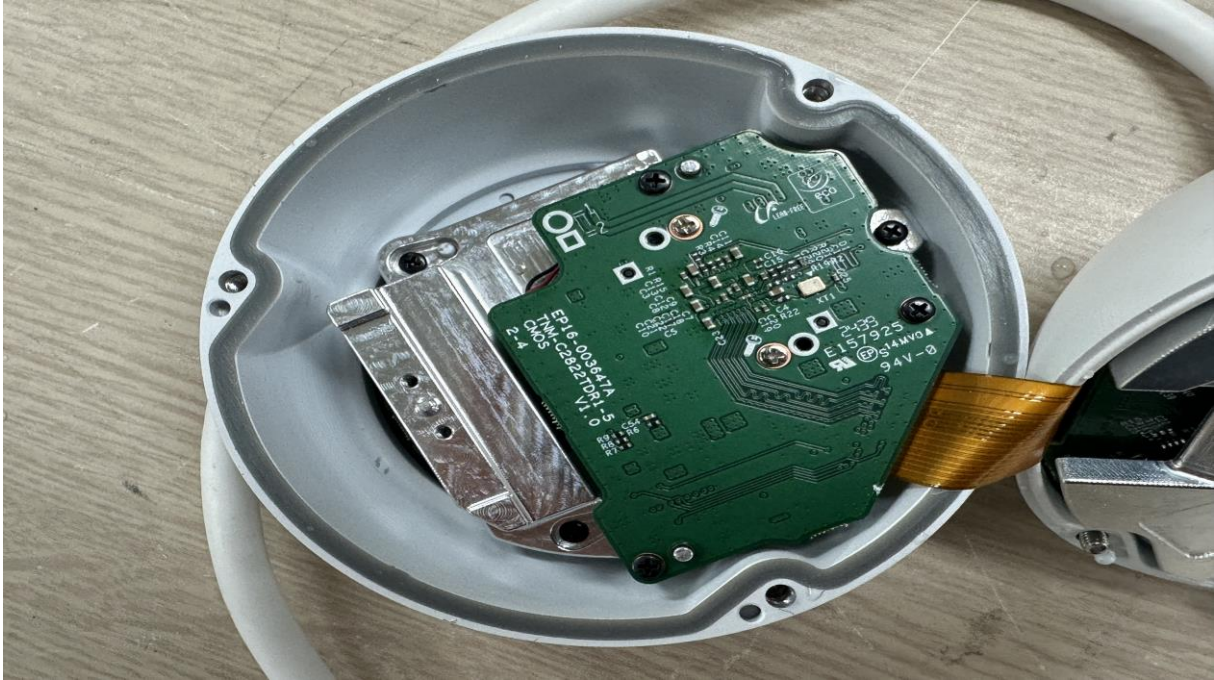
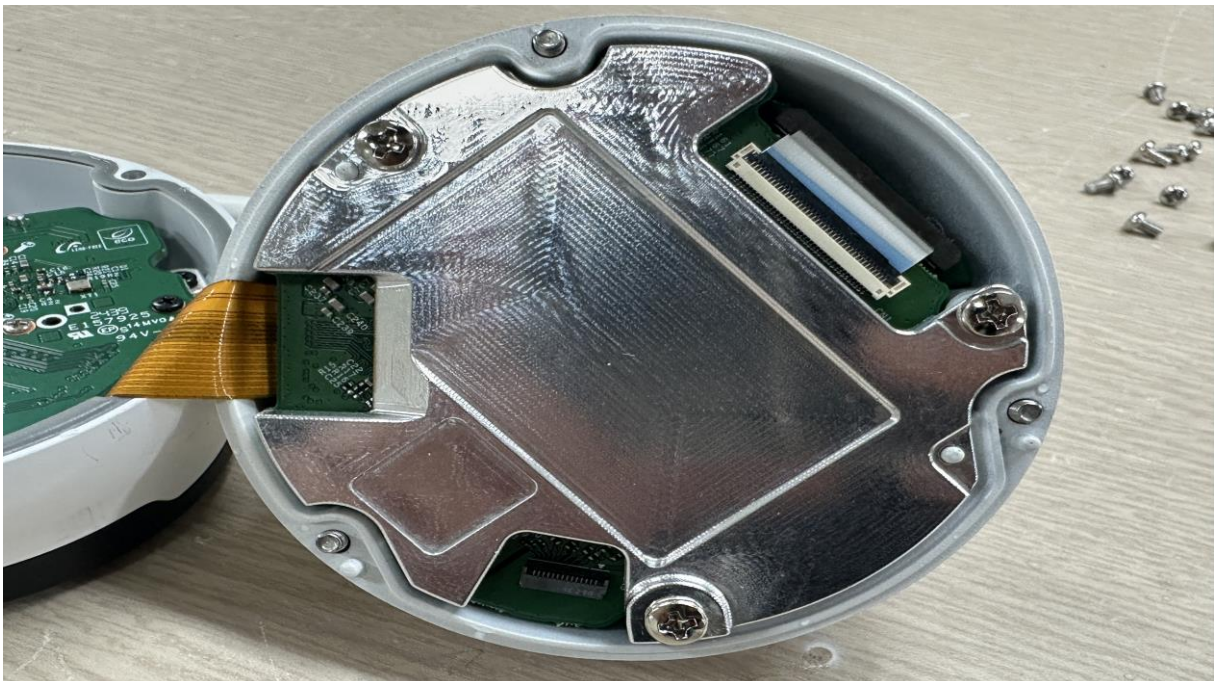
4.2.2 Product internal images after test [The second characteristic numeral test]
